REHABILITATION PLAN FOR THE SPURGEON HOUSE

115 SOUTH COUNCIL STREET, MUNCIE, INDIANA

A 6-HOUR CREATIVE PROJECT

MASTER OF SCIENCE IN HISTORIC PRESERVATION

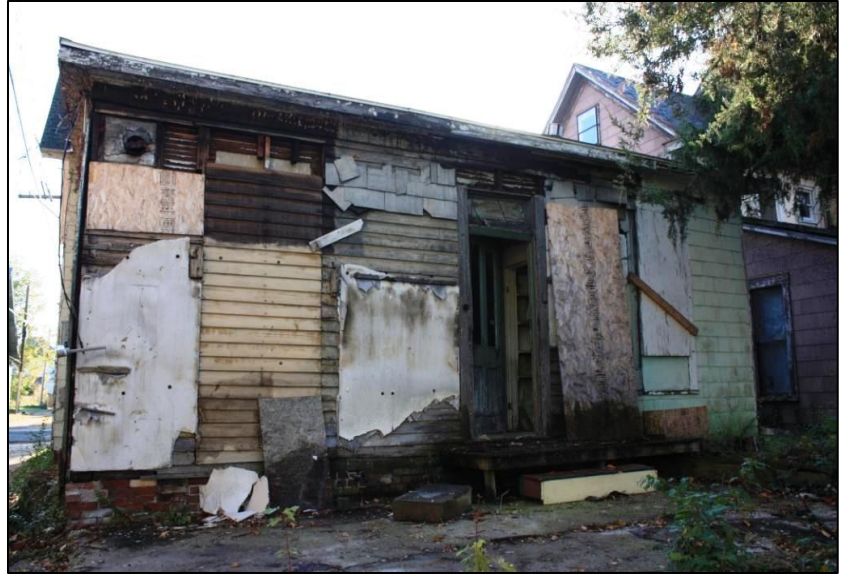
Figure 6: Photo of west elevation. Photograph by Emily Husted, 18 October 2010.

South of the door approximately 2 feet is an original window opening, but the window was removed at an unknown date. The asbestos shingles were removed at an unknown date exposing the original wood siding and parts of the plaster and lath. Plywood sheeting and wood boards were used to cover the exposed areas. The entire elevation is currently covered by wood boards and siding (025). The shed roof slopes toward the west.

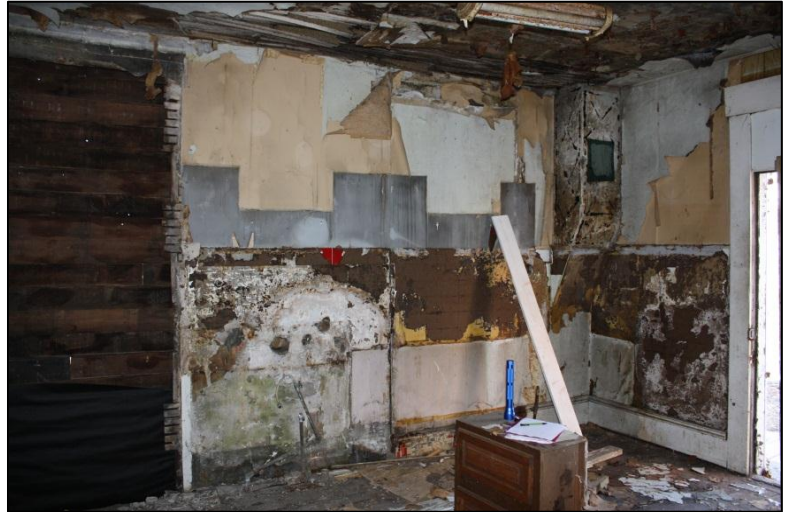
Figure 12: Photo of the door and window on the north wall in the room 4. Photograph by Emily Husted, 2 February 2012.

wall (Figure 12) (101). The door and frame were removed when the west exterior wall was boarded up in the summer of 2011. The door opening is surrounded by original painted oak wood trim, which has also been removed (133, 134). The other exterior entrance is through an original doorway, D4, located on the north wall of the kitchen (096, 102, 104). The door is surrounded by original painted oak wood trim and a single-light transom (104). The interior entrance into room 4 is through an original opening at the southeast corner of room 4 located on the east wall (098). The opening is surrounded by original oak wood trim and a single-light transom. The trim is stained on the dining room side and painted on the kitchen side (080). Window W10 on the north wall is

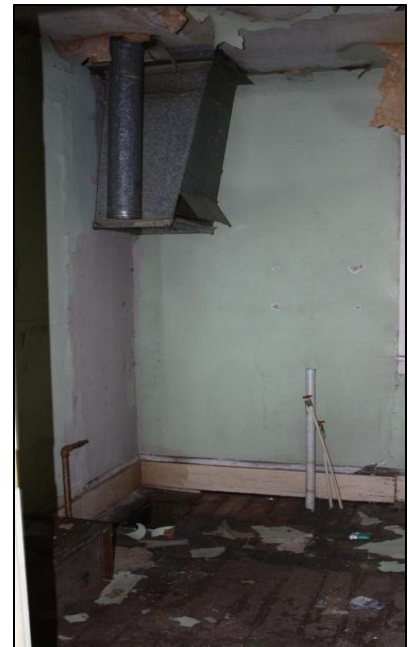
Figure 14: Photo depicting the
aluminum vents in room 5.
Photograph by Emily Husted, 8
October 2010.

out of the floor, three of which are PVC pipes and the other is copper. The ceiling is plaster and lath (112). One circular aluminum vent hangs from the ceiling and served the former hot water heater. A rectangular aluminum vent served the former furnace. Both are located in the southeast corner (Figure 14) (116).
